HR-73

THE FLEXURAL FATIGUE STRENGTH OF PRESTRESSED STEEL I-BEAMS

May 1, 1962

Project 453-S

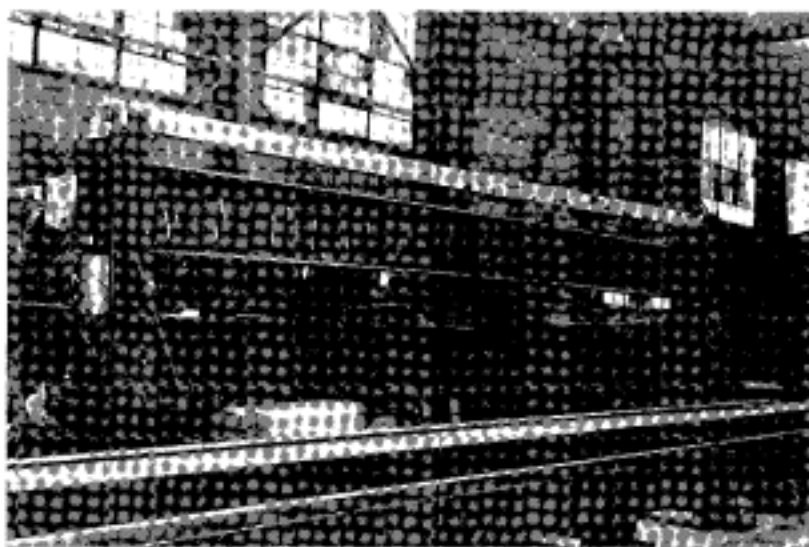
Fig. 2. Elevation of Des Moines beam (top beam) during fabrication.

The first beam was fabricated in Des Moines, Iowa, at the Pittsburgh-Des Moines Steel Company's plant. It is referred to as the Des Moines Beam. The beam was supported as shown with a 30,000 lb jack load applied at the center of the 25 foot simple span (figures 2, 3). The top and bottom T-1 plates had previously been positioned in an unstressed condition and were held by clamps. While the jack force was still present, the cover plates were welded to the flanges of the beam with continuous

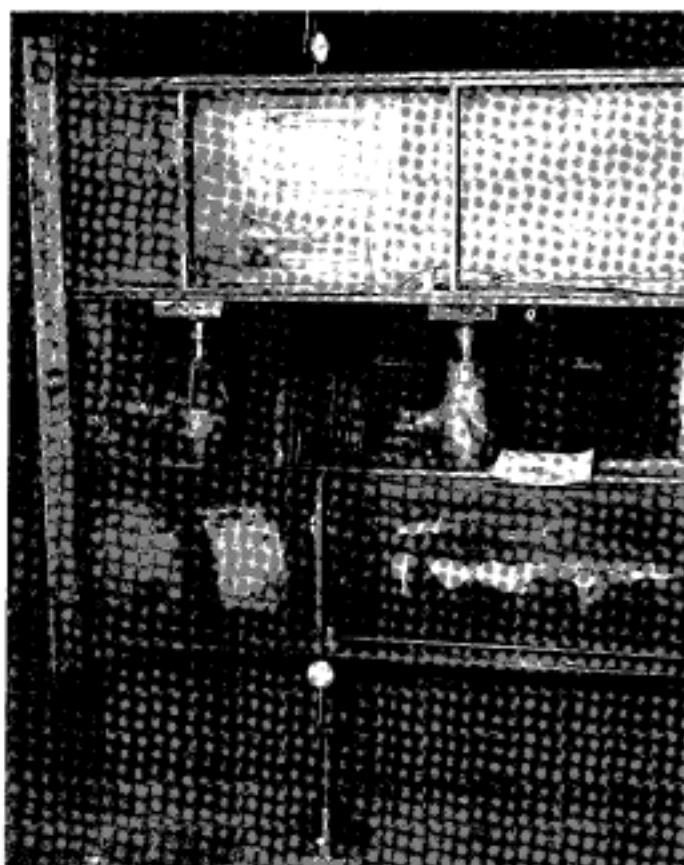
Fig. 3. Elevation at center of span during fabrication of Des Moines beam (single prestressing jack has been replaced by screw jacks).

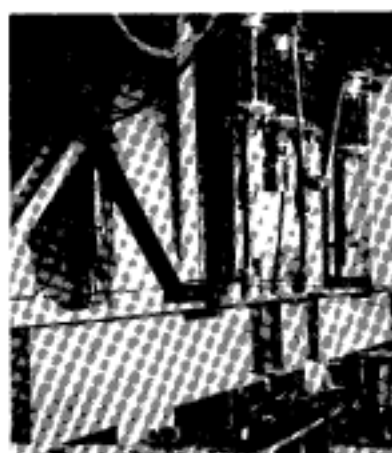
Fig. 7. Elevation of Des Moines beam (side 1) during fatigue test.

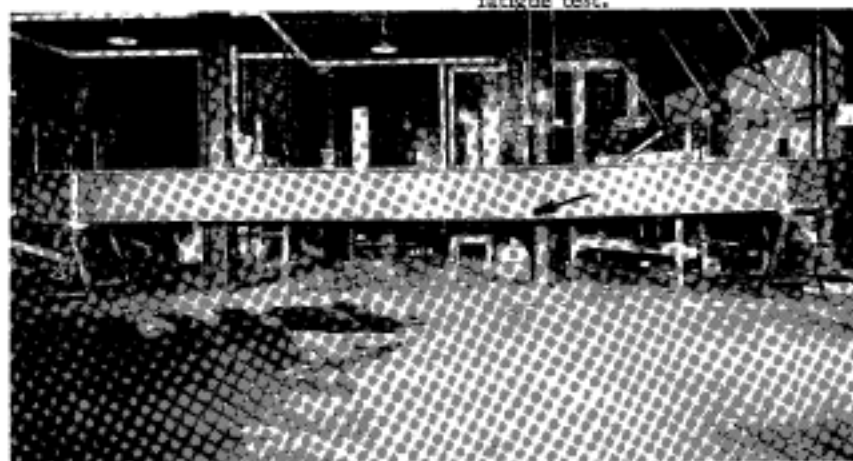
- (1) Both fractures occurred in the shear span adjacent to the roller support. The fracture was approximately 6 inches from the load point in the Ames beam (figure 12) and 1 foot from the load point in the Des Moines beam (figure 8).

Fig. 8. Elevation of Des Moines beam (side 1) after fatigue failure.

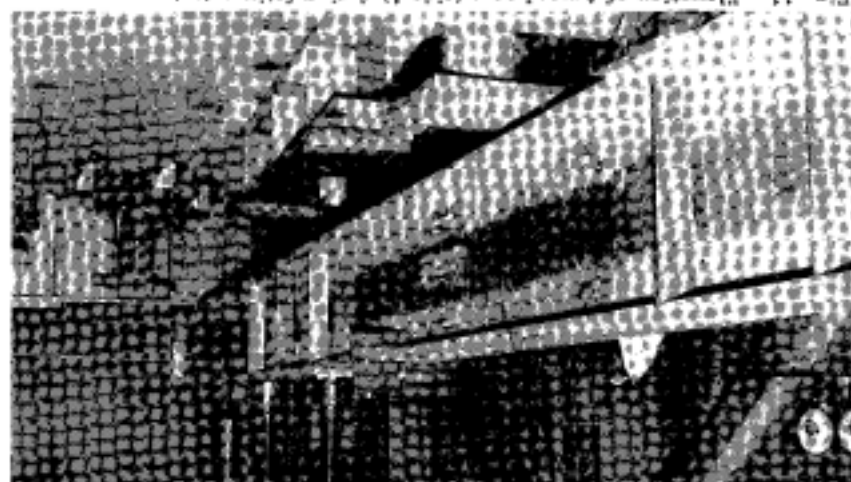
Fig. 11. Elevation of Ames beam (side 1) during fatigue test.

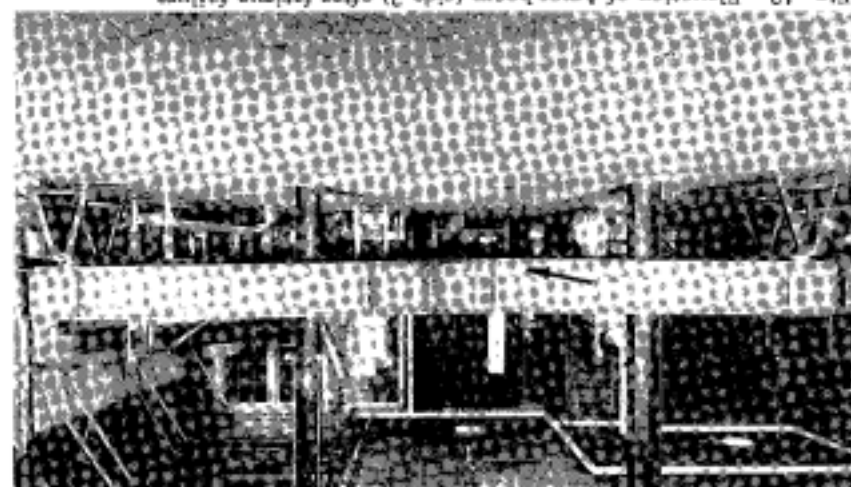
Fig. 12. Elevation of Ames beam (side 2) after fatigue failure.

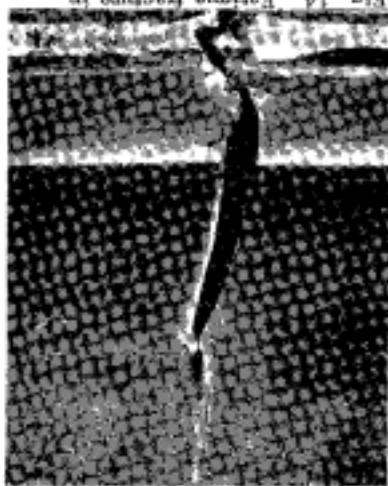
- (2) The fractures formed at points of high stress concentration. In the Ames beam, this was observed to be an abrupt change in the weld area (figures 13, 14), while the Des Moines beam had a small notch on the edge of the bottom cover plate.

- (3) The fractures were smooth on one side (figures 10, 13), on the other they were jagged and torn (figures 9, 14). The similarities of the two fractures and the fact that the Des Moines beam first cracked on the smooth side of the flange (side 2) make it reasonable to assume that the Ames beam also cracked first on the smooth side (side 1).

Fig. 14. Fatigue fracture in Ames beam (side 2).

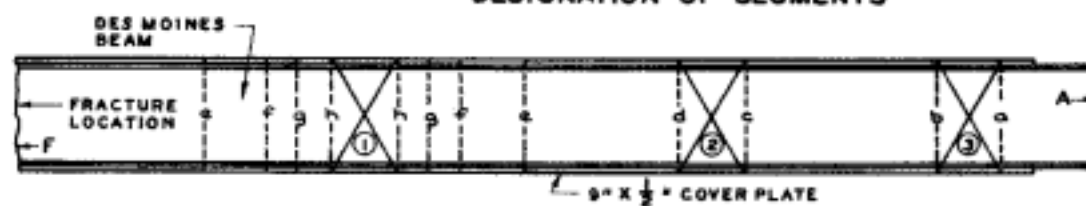
FIG. 18. INFLUENCE OF SAWING ON STRAINS IN BOTTOM PLATE FOR SEGMENT I

To ascertain what effect the fatigue crack had on the state of stress in the individual segments, strain readings were obtained after successively cutting the Des Moines beam into shorter lengths. The initial set of readings was taken in the bottom plate at segment 1 after the beam had been cut at the fracture location to a length of about 15 feet. This is denoted as segment AF (figure 18). Successive sets of readings were taken in the bottom plate of segment 1 following sawing to form segments aF, bF, cF, dF, ee, ff, gg, and hh. Each set of readings was averaged and expressed as a percent of the total change occurring after final cutting. These were plotted (figure 18), and the resulting curve shows that very little change occurred until segment ff, which is 3 feet long, remained. Therefore, it is apparent that the state of stress was not appreciably affected when the fatigue fracture occurred.
